Manhole Inspection Summary

Manhole # S13S__004MH

Insp Date: **1/6/09 10:34 AM**

Location Address: **Desoto Rd.**

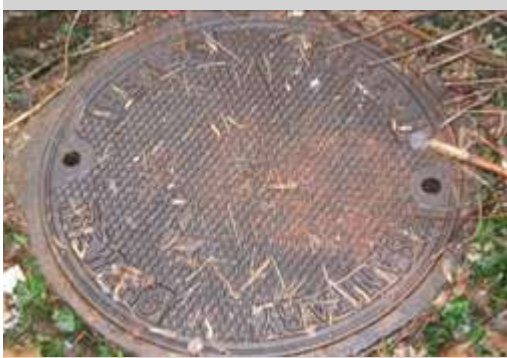
MH Lid

Cover Shape: **Circular** Diameter: **25.** (in.) Length: **0** (in.) Dist A/B Grade: **24** (in.)
75

Type: **Sanitary** Condition: **Sound** Cover Material: **Cast Iron**

Frame Offset: **0** (in.) Condition: ☐ Sound ☐ Cracked ☒ **Leaks**

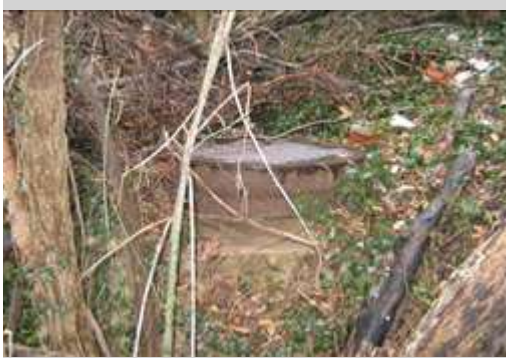
above grade

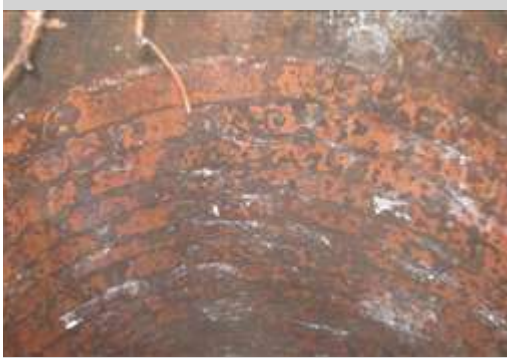
Defect 4

Infiltration: ☐ None ☒ **Joint** ☐ Cracks ☐ Mortar ☐ Roots ☒ **Wall**

frame, chimney and corbel infiltration

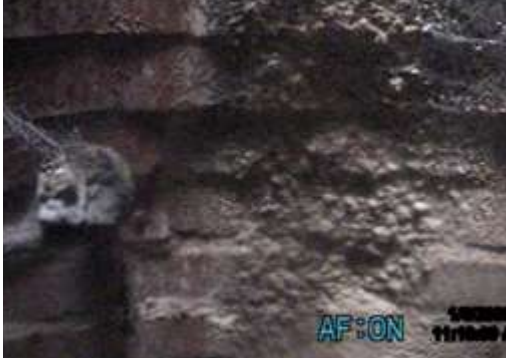
Defect 3

Infiltration: ☐ None ☒ **Joint** ☐ Cracks ☐ Mortar ☐ Roots ☒ **Wall**

barrel infiltration

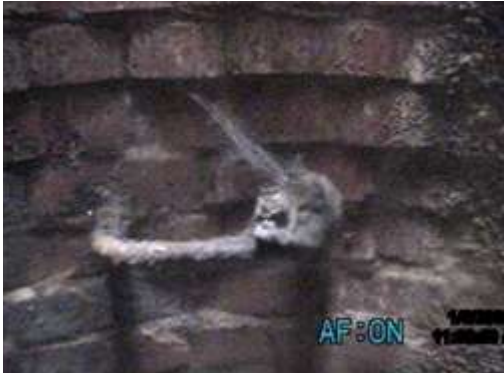
Defect 2

Steps Count: **8** Missing: **0** ☒ **Corroded**

corroded rung

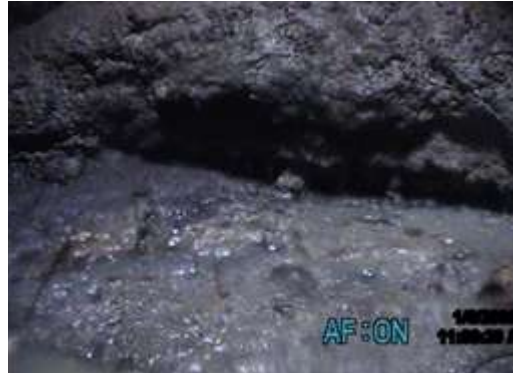
Defect 1

Condition: ☐ Sound ☐ Cracked ☐ Root Intrusion ☐ Deteriorated ☐ Leaks ☒ **Debris**

debris on the bench

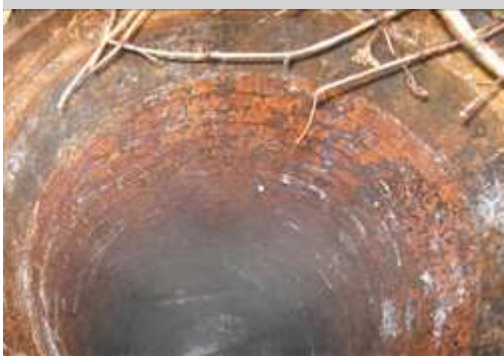
Defect 5

Infiltration: ☐ None ☒ **Joint** ☐ Cracks ☐ Mortar ☐ Roots ☒ **Wall**

Corbel infiltration

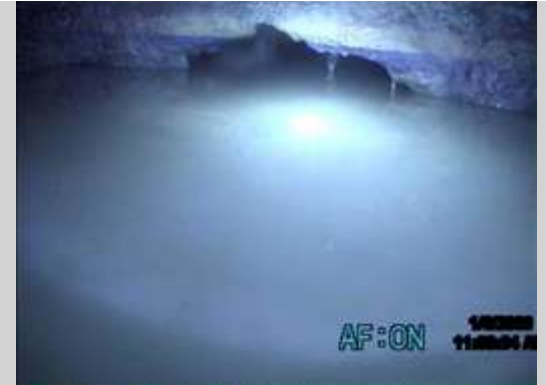
12 O'Clock Outflow

12 in. Circular Gravity Sewer
Pipe Out @ 12 O'Clock

Deposits: ☐ None ☐ Mud ☒ Sludge ☐ Debris ☐ Grease

Silt Depth: 5 (in.) Deposits Extent: Heavy

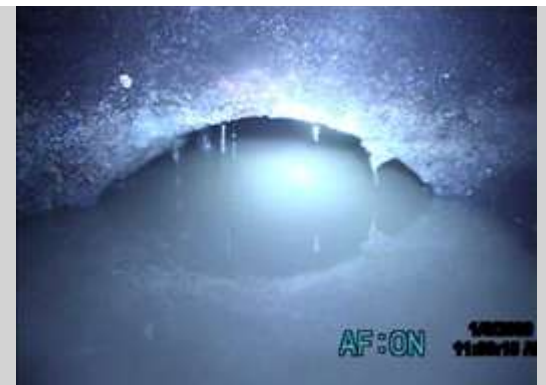
6 O'Clock Inflow

12 in. Circular Gravity Sewer
Pipe In @ 6 O'Clock

Deposits: ☐ None ☐ Mud ☒ Sludge ☐ Debris ☐ Grease

Silt Depth: 5 (in.) Deposits Extent: Heavy
